The village of Harrold suffered flooding in December 2020. Under the Flood and Water Management Act 2010, Bedford Borough Council as the Lead Local Flood Authority (LLFA) has the duty to investigate the flood event. The scope of this flood investigation is to identify the source, cause and impact of flooding from available information; identify actions completed by relevant Risk Management Authorities (RMAs) in response to the flood event; and consider actions to better understand and manage the risk of flooding in the affected area.

## FLOOD EVENT & CAUSE

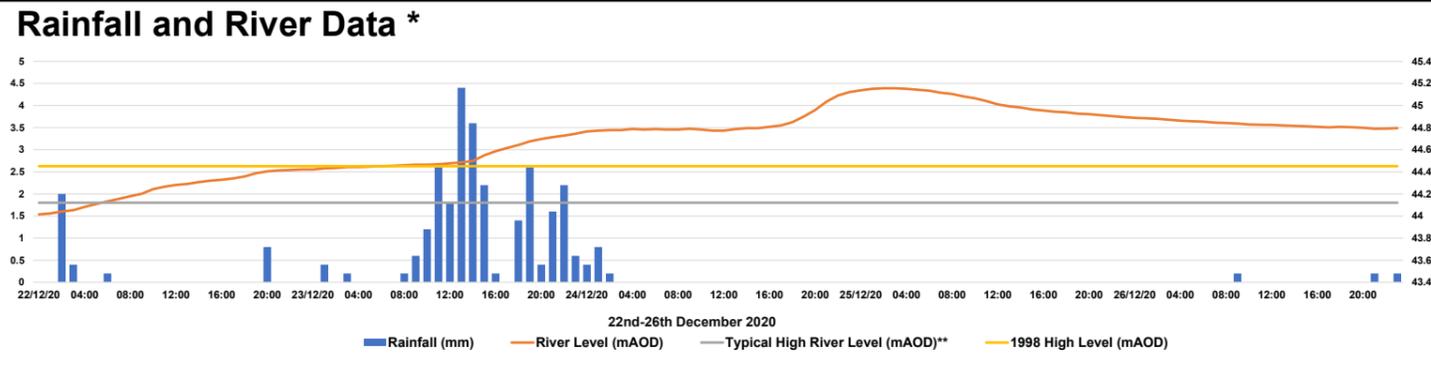
### Rainfall and River Gauges

<b>Nearest Rain Gauge</b>	Olney
<b>Distance to Gauge</b>	7.69 km
<b>Nearest River Gauge</b>	Turvey
<b>Distance to Gauge</b>	4.01 km

The graph identifies that the main rainfall event at the nearest rainfall gauge to Harrold occurred between 08:00 on December 23rd and 03:00 on December 24th. The total rainfall volume is recorded as 27mm with a peak rainfall intensity of 4.4mm/hour. This single event saw just under half of the 55mm of rainfall which is expected for the whole month of December on average.

The River Great Ouse is located approximately 890m to the south of the affected area. The graph shows that the river levels in the Great Ouse were elevated above the 'typical high river level' from the early hours of December 22nd and stayed above this level until beyond December 26th. The 'typical high river level' at the nearest gauge station is identified as 44.1m Above Ordnance Datum (AOD). River levels above this are only expected to be recorded 5% of the time. For context, the 1998 peak flood level is included, which was recorded at 44.45m AOD, and the graph shows that the December 2020 river levels exceeded the 1998 level from approximately 02:00 on December 23rd.
