The area around Keysoe Row East in the Bolnhurst and Keysoe civil parish suffered flooding in December 2020. Under the Flood and Water Management Act 2010, Bedford Borough Council as the Lead Local Flood Authority (LLFA) has the duty to investigate the flood event. The scope of this flood investigation is to identify the source, cause and impact of flooding from available information, identify actions completed by relevant Risk Management Authorities (RMAs) in response to the flood event, and consider actions to better understand and manage the risk of flooding in the affected area.

SOURCE OF FLOODING: Surface Water

FLOOD EVENT & CAUSE

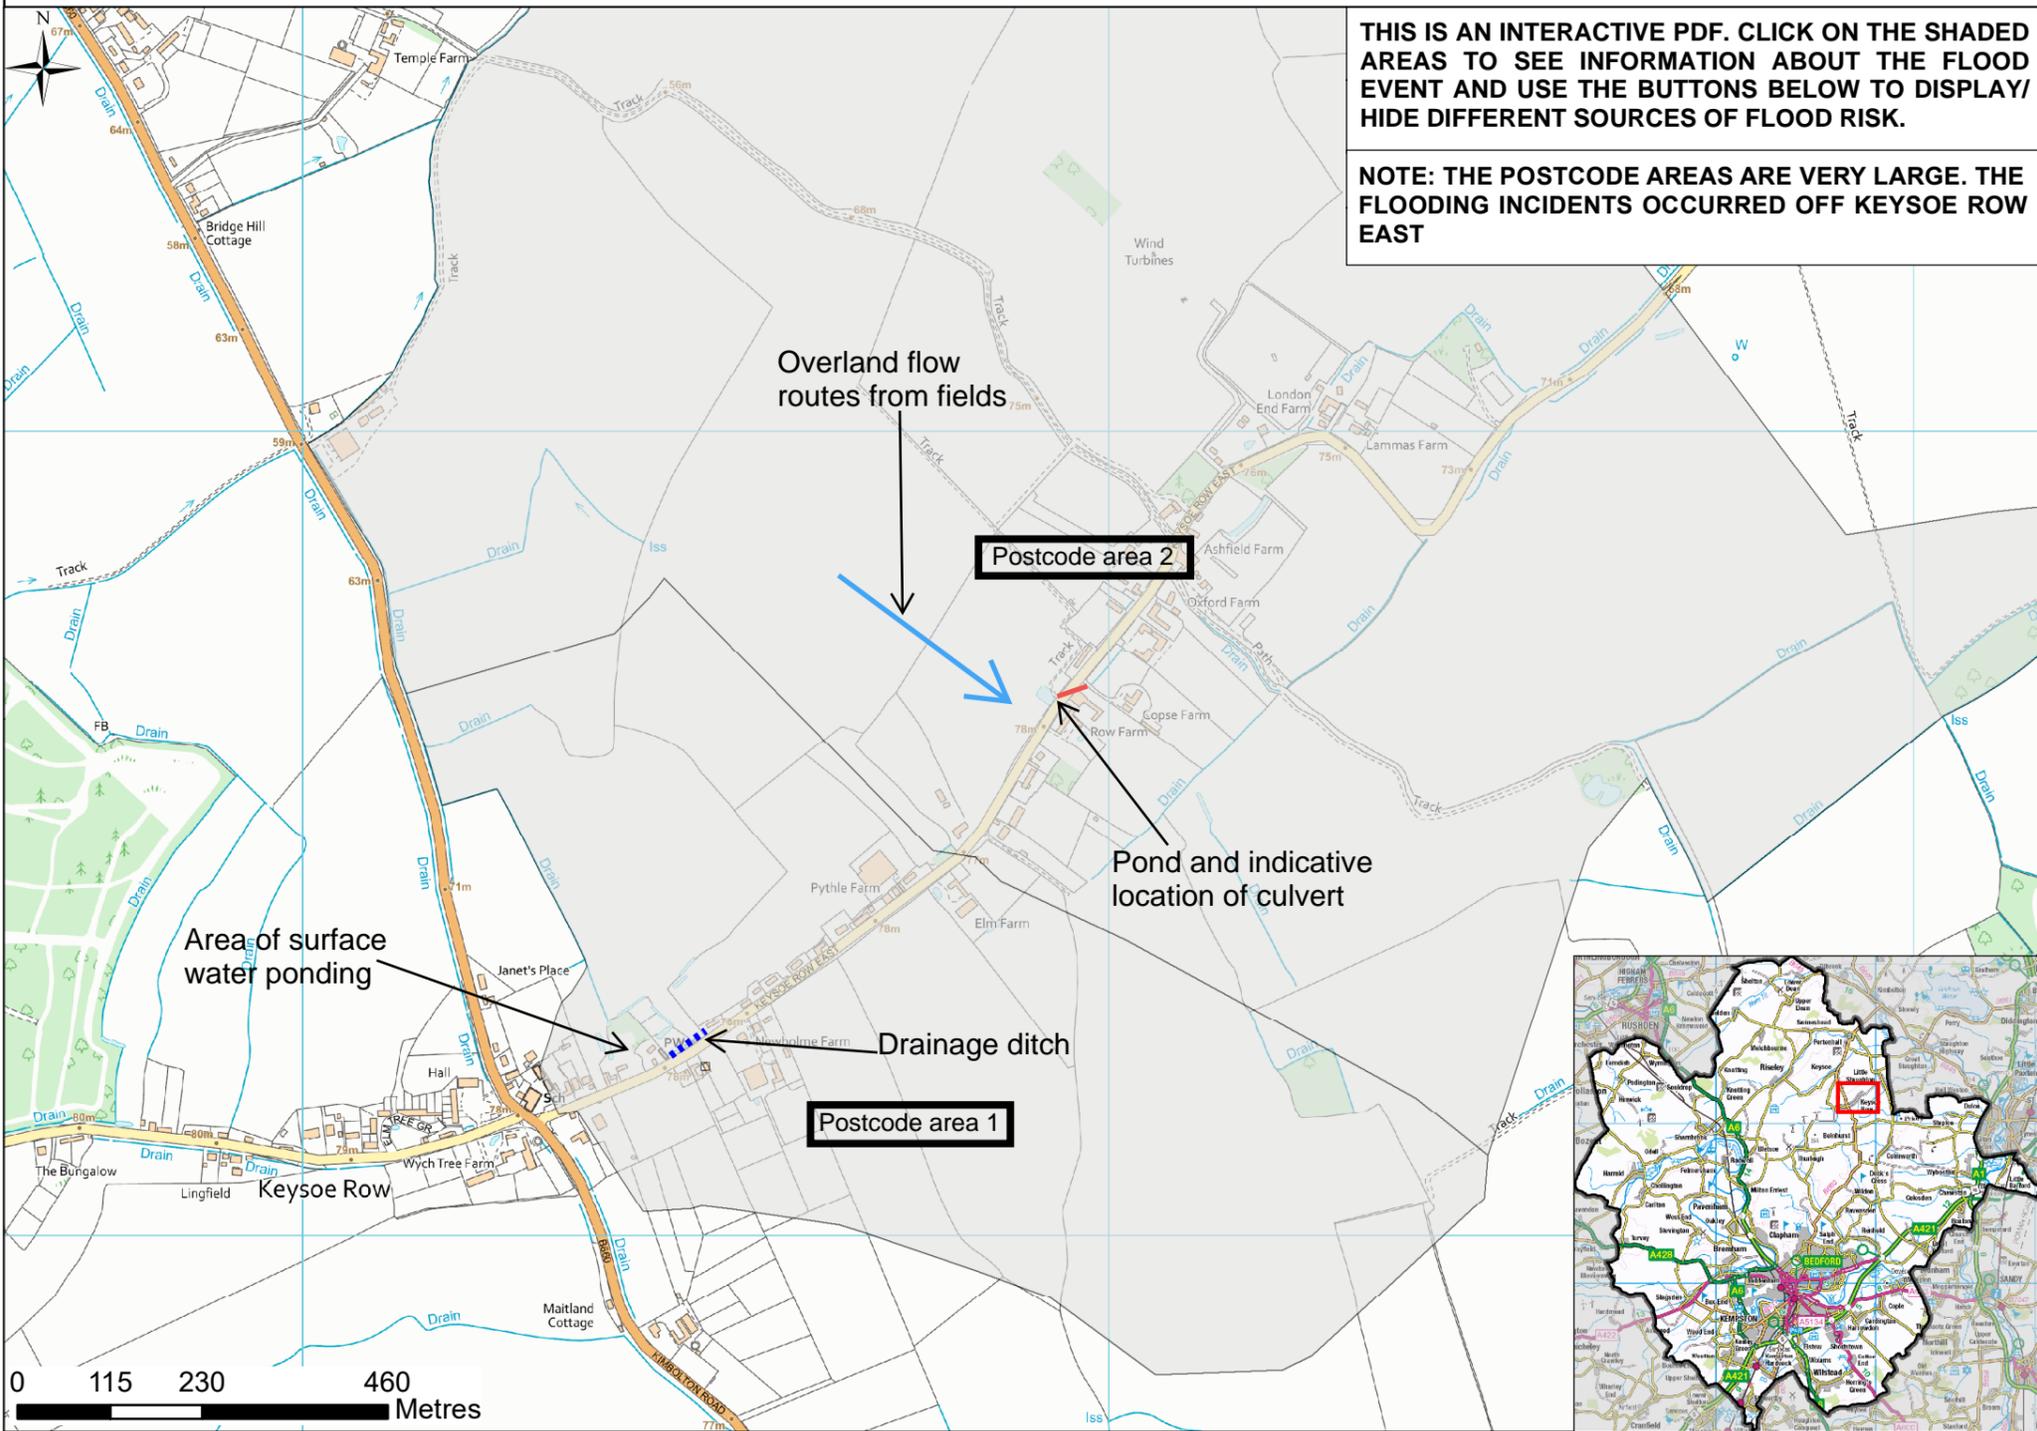
NOTE: THE POSTCODE AREAS ARE VERY LARGE. THE FLOODING INCIDENTS OCCURRED OFF KEYSOE ROW EAST

Two residential properties reported internal flooding on December 23rd. One property reported water seeping in through the wall from an adjacent ditch, and the other property reported water encroaching through the garden and patio door from an adjacent pond and fields.

Postcode area 1: It is thought that the heavy rainfall overwhelmed the capacity of the drainage ditch running parallel to the northern side of Keysoe Row East adjacent to one of the properties. This flood mechanism is consistent with the Environment Agency Flood Risk from Surface Water mapping¹, which shows that the property is located adjacent to an area at 'high' risk of surface water flooding, meaning that the chance of flooding is greater than 3.3% in any given year. The mapping shows areas of surface water ponding within and surrounding the property, which suggests that the area is a localised low point where surface water runoff is likely to pond following heavy rainfall events. In addition, the British Geological Survey (BGS) records² show that the underlying geology is a classified Secondary Aquifer, which means there is the potential for elevated groundwater. It is thought that elevated groundwater contributed to the floodwater that reportedly seeped through the walls.

Postcode area 2: There is a natural pond located just west of the other affected property to the north of Keysoe Row East. The outfall of the pond is culverted beneath the road and discharges into a drainage ditch. It was reported that the culvert beneath the road was blocked during the flood event, such that water backed up and overtopped the banks of the pond. In addition, the heavy rainfall is thought to have caused overland flow routes on the fields to the northwest, contributing to the flooding experienced. This flood mechanism is partially consistent with the Environment Agency mapping, which shows that the area just east of the pond is at 'high' risk of surface water flooding. The affected property itself is shown at 'low' risk of surface water flooding (chance of flooding between 0.1% and 1% in any given year), however, the blocked culvert would have caused more water to back up than would be expected.

In conclusion, December 2020 was a very wet month with an average rainfall of 108mm across East Anglia, which is 95% higher than the December average³. The three months leading up to December also saw higher than average rainfall such that by December 23rd the ground was already saturated. This, combined with the rainfall recorded during the dates in question, meant that surface water was less able to infiltrate into the ground and more likely to run off into drainage ditches and form overland flow routes. It is thought that a combination of heavy rainfall, overland flow routes, and a blocked culvert contributed to the flooding experienced. Any maintenance issues with ditches and highway drainage along Keysoe Row East would have exacerbated the flooding.

Timescale	Action	Responsible Party
Complete	Investigate highway drainage on Keysoe Row East including the culvert connecting the pond to the ditch and clear any debris. This was completed in February and March 2021.	Bedford Highways
Complete	Liase with the landowner to maintain the drainage ditches and ponds adjacent to Keysoe Row East to provide additional capacity and potentially reduce flooding at the affected properties.	Lead Local Flood Authority / Landowners
Ongoing	Investigate the potential benefits of constructing a new headwall to ensure the pond drainage mechanism works effectively and water can discharge freely.	Bedford Highways
Medium term (6-12 months)	Investigate the suitability of flood protection measures for the affected properties (e.g. flood barriers, waterproof wall sealant, non-return valves, etc.), develop a flood action plan, and investigate the condition of drainage features. Specialist advice should be sought from a Property Flood Resilience (PFR) surveyor.	Property owner

Medium term (6-12 months)	Investigate the potential benefits and local appetite for a community flood group. The flood group should enable access to flood kits, flood action plans, and information about flood warnings/alerts and PFR.	Lead Local Flood Authority
Long term (2-4 years)	Investigate the potential benefits of improvement works to local drainage, which could include additional highway/land drainage and formalising the pond to the north of Keysoe Row East to hold more surface water runoff from the surrounding fields and ditches.	Lead Local Flood Authority / Riparian Owner

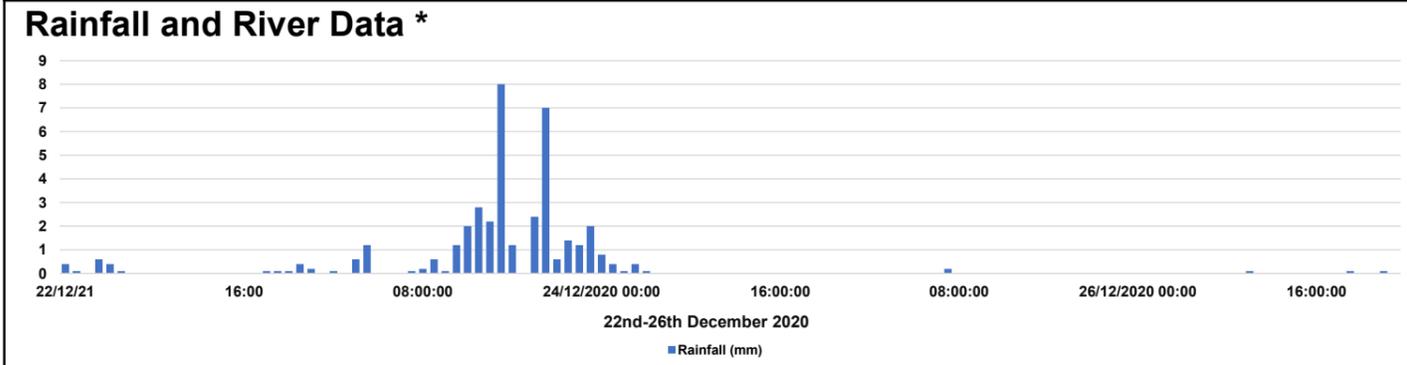
Rainfall and River Gauges

The graph identifies that the main rainfall event at the nearest rainfall gauge to Keysoe Row East occurred between 08:00 on December 23rd and 04:00 on December 24th. The total rainfall volume is recorded as 34.7mm with a peak rainfall intensity of 8mm/hour. This single event saw more than half of the 55mm of rainfall which is expected for the whole month of December on average.
