The village of Carlton suffered flooding in December 2020. Under the Flood and Water Management Act 2010, Bedford Borough Council as the Lead Local Flood Authority (LLFA) has the duty to investigate the flood event. The scope of this flood investigation is to identify the source, cause and impact of flooding from available information, identify actions completed by relevant Risk Management Authorities (RMAs) in response to the flood event, and consider actions to better understand and manage the risk of flooding in the affected area.

**SOURCE OF FLOODING:** Surface Water

## FLOOD EVENT & CAUSE

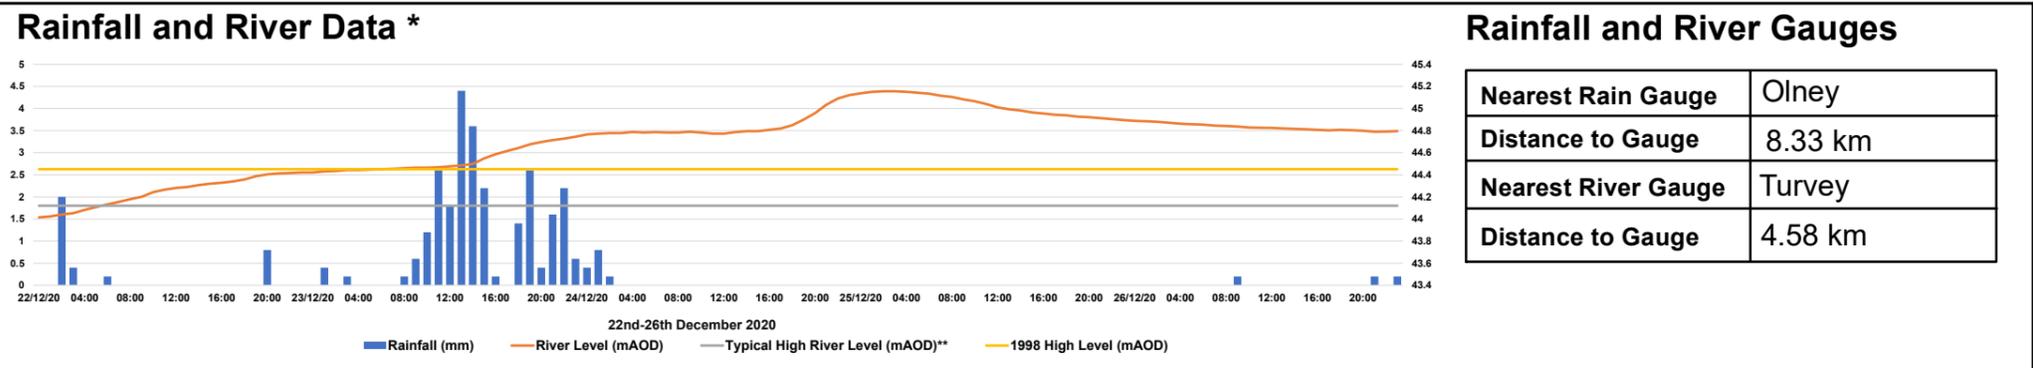
### Rainfall and River Data Interpretation

The graph identifies that the main rainfall event at the nearest rainfall gauge to Carlton occurred between 08:00 on December 23rd and 03:00 on December 24th. The total rainfall volume is recorded as 27mm with a peak rainfall intensity of 4.4mm/hour. This single event saw just under half of the 55mm of rainfall which is expected for the whole month of December on average.

The River Great Ouse is located approximately 1.1km to the north of the affected area on The Causeway. The river level at the nearest river gauge to Carlton is recorded to have risen above the 'typical high river level' in the early hours of December 22nd and stayed above this level until beyond December 26th. The 'typical high river level' at the nearest gauge station is identified as 44.1m Above Ordnance Datum (AOD). River levels above this are only expected to be recorded 5% of the time. For context, the 1998 peak flood level is included, which was recorded to be 44.45m AOD. The graph shows that the December 2020 river levels exceeded the 1998 level from approximately 02:00 on December 23rd.
