The village of Carlton suffered flooding in December 2020. Under the Flood and Water Management Act 2010, Bedford Borough Council as the Lead Local Flood Authority (LLFA) has the duty to investigate the flood event. The scope of this flood investigation is to identify the source, cause and impact of flooding from available information; identify actions completed by relevant Risk Management Authorities (RMAs) in response to the flood event; and consider actions to better understand and manage the risk of flooding in the affected area.

SOURCE OF FLOODING: Surface Water

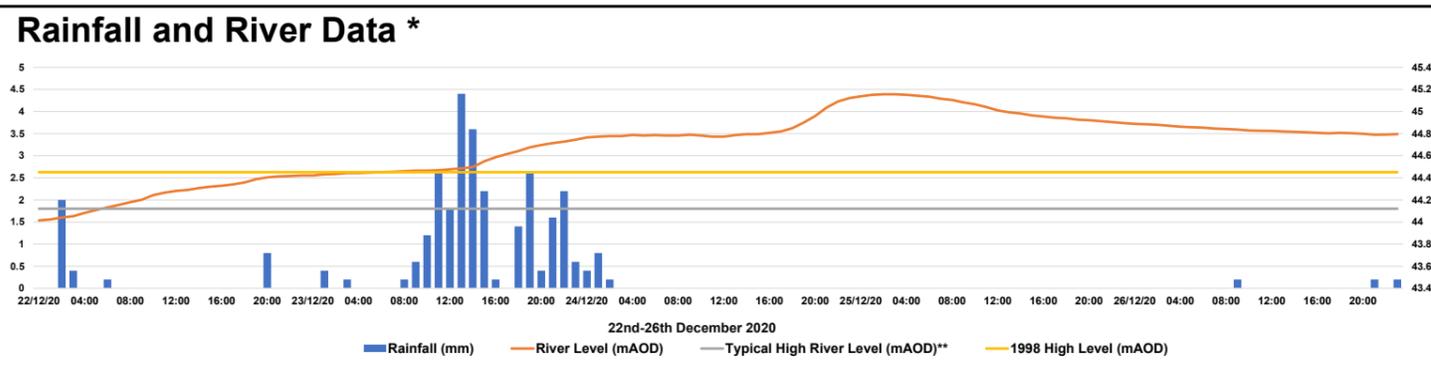
Rainfall and River Gauges

Nearest Rain Gauge	Olney
Distance to Gauge	7.33 km
Nearest River Gauge	Turvey
Distance to Gauge	3.58 km

Rainfall and River Data Interpretation

The graph identifies that the main rainfall event at the nearest rainfall gauge to Carlton occurred between 08:00 on December 23rd and 03:00 on December 24th. The total rainfall volume is recorded as 27mm with a peak rainfall intensity of 4.4mm/hour. This single event saw just under half of the 55mm of rainfall which is expected for the whole month of December on average.

The River Great Ouse is located approximately 500m to the north-west of The Marsh. The river level at the nearest river gauge to Carlton is recorded to have risen above the 'typical high river level' in the early hours of December 22nd and stayed above this level until beyond December 26th. The 'typical high river level' at the nearest gauge station is identified as 44.1m Above Ordnance Datum (AOD). River levels above this are only expected to be recorded 5% of the time. For context, the 1998 peak flood level is included, which was recorded to be 44.45m AOD. The graph shows that the December 2020 river levels exceeded the 1998 level from approximately 02:00 on December 23rd.
