FORMAL FLOOD INVESTIGATION REPORT

Upper Dean, Bedfordshire

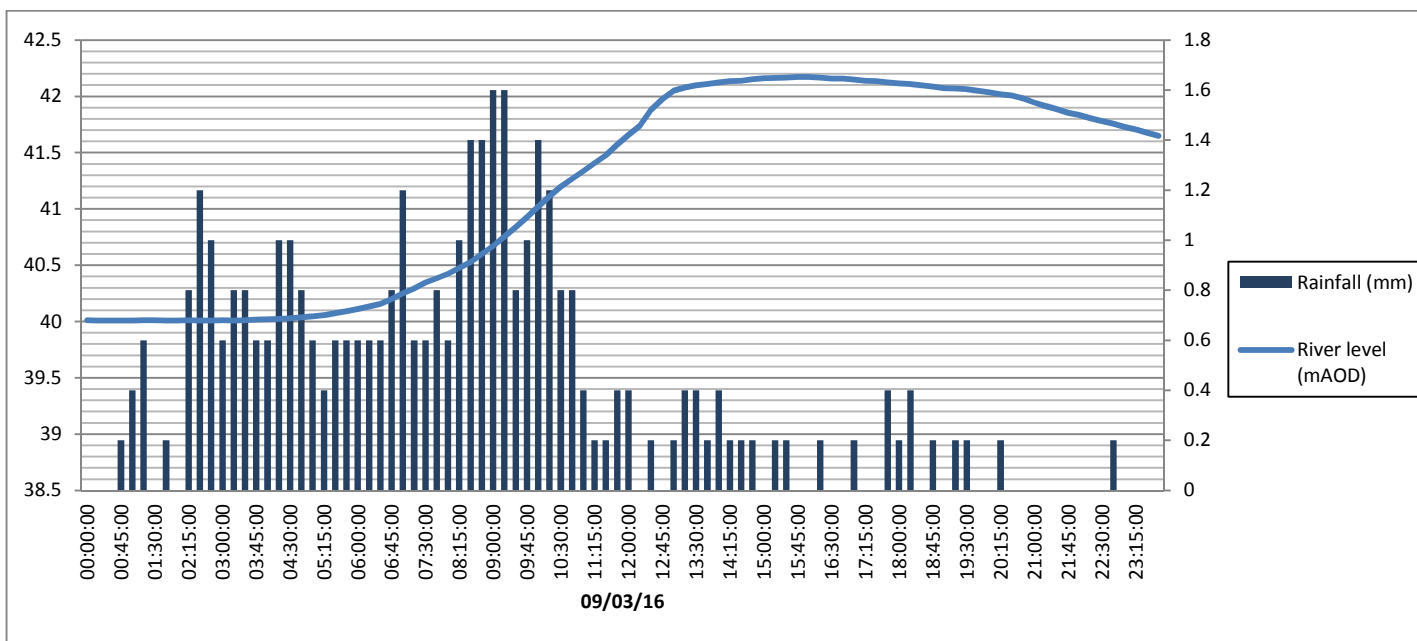
Figure 3.1 Rainfall and River Levels for Covington 09/03/16

Data was retrieved from the Environment Agency rain gauges in Covington which is approximately 2.5 miles North East of Upper Dean. 39mm of rainfall was recorded at the Environment Agency's rain gauge at Covington between 00:30 and 20:30 on Wednesday 9th March. The amount of rainfall is equal to the average rainfall expected for the whole of March (Figure 3.1)

Measurements from Covington Brook recorded water levels rapidly rising from 07:00 and peaking at 15:45 on Wednesday 9th March 2016. The water level peaked at 42.17AOD (metres above Ordnance Datum) (Figure 3.1).

A tributary of the River Till runs through Upper Dean and joins the River Till downstream of Lower Dean. Water came out of bank and flooded Brook Lane and properties along Brook Lane. Figure 3.1 shows how quickly river levels came up following the intense rainfall. Surface water also contributed to this flooding where it could not get away through the drainage system.
